# Public Works

AUGUST 19, 2011

## Spillway Repair Completed

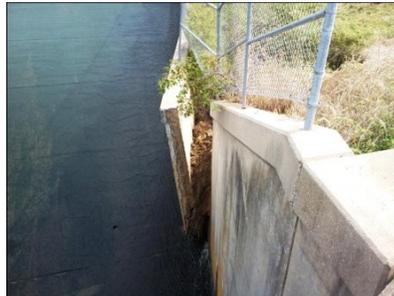
On Tuesday, September 14, 2010 a hole was discovered next to the Silver Lake spillway retaining wall.

Top Left - Spillway Wall Sept. 2010  
Top Right - Spillway Wall August 2011  
Center Left - Phase I - November 2010  
Center Right - Lowering the lake - May 2011  
Bottom Left - Removing the old wall - June 2011  
Bottom Right - New Wall construction - Summer 2011

Following the recommendations of the engineers from Burns and McDonnell Engineering and Geotechnology the Street and Alley division worked to construct a ditch to divert drainage from the highway and placed plastic over the eroded area to prepare for the first phase of the emergency repair.
